INDOOR AIR QUALITY ASSESSMENT

**Gloucester High School
Administration and Guidance Offices
32 Leslie O. Johnson Road
Gloucester, Massachusetts**

Prepared by:
Massachusetts Department of Public Health
Center for Environmental Health
Emergency Response/Indoor Air Quality Program
March 2005

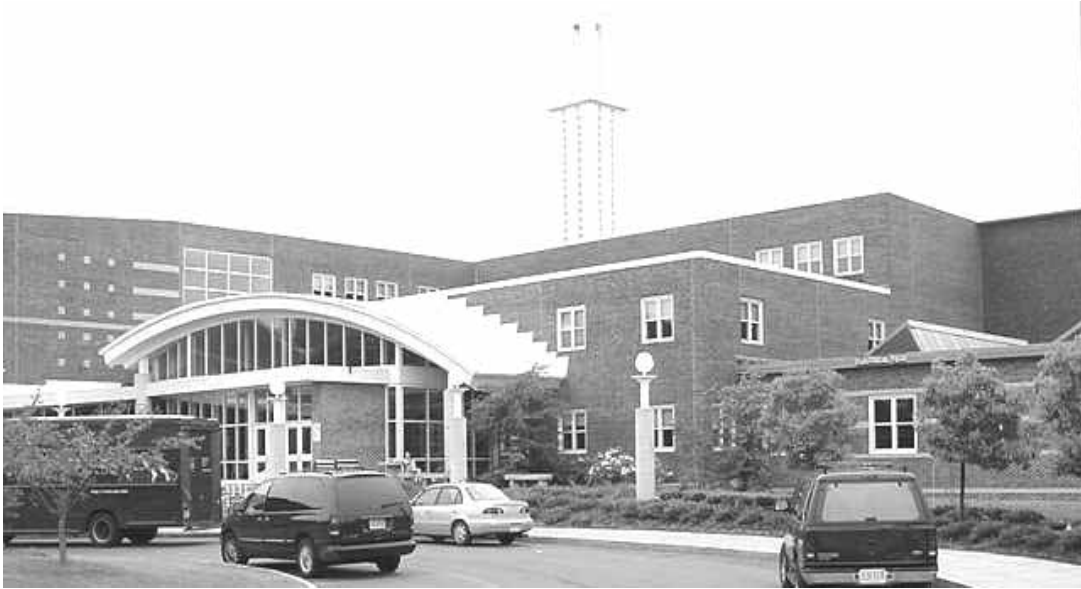
Picture 1

The school is a multi-wing, brick building renovated from 1996 to 1998. The administration and guidance/counseling offices (the offices) are located on the first floor of a two-story wing that was added during the renovation project (Picture 1). The administration office and guidance/counseling suites are separated by a corridor that opens into the foyer entrance of the building. The faculty workroom is also located in this first floor area. The

Library, Administration and Guidance Wing

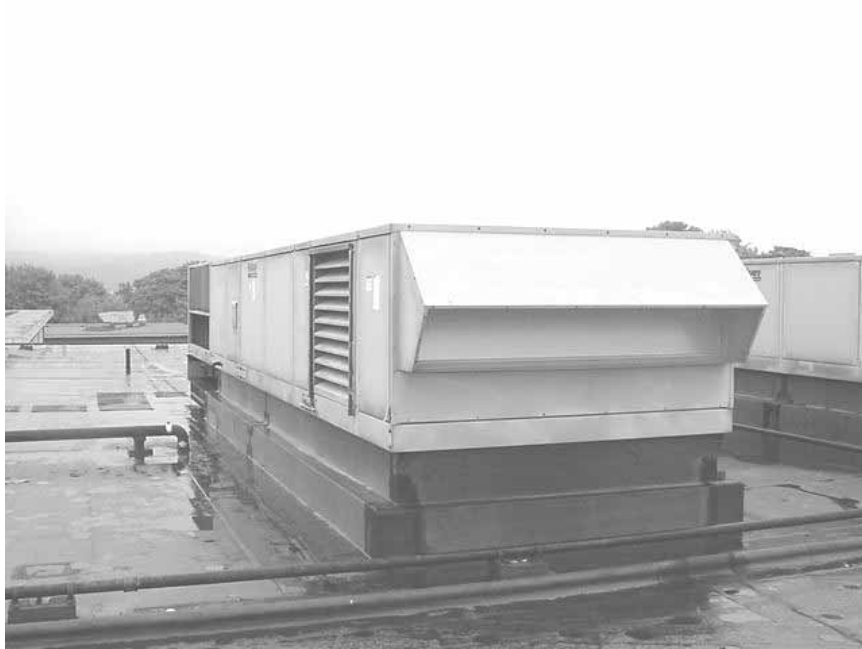
Picture 2

A heating, ventilation and air conditioning (HVAC) system provides ventilation to the offices and library. Fresh air is provided by a rooftop-mounted air-handling unit (AHU) (Picture 2). The AHU is connected to ducts that supply fresh air to rooms via ceiling mounted air diffusers. By design, air diffusers are equipped with fixed louvers. These louvers direct the air supply to travel along the ceiling and down the walls, thereby creating airflow. Exhaust ventilation is provided by infiltration of air into the ceiling plenum, which is a space between the ceiling tile system and floor above. Air from the ceiling plenum is returned to the AHUs. This system has no ductwork, but uses the entire space above the ceiling tile system to return air to the AHU.

Offices AHU

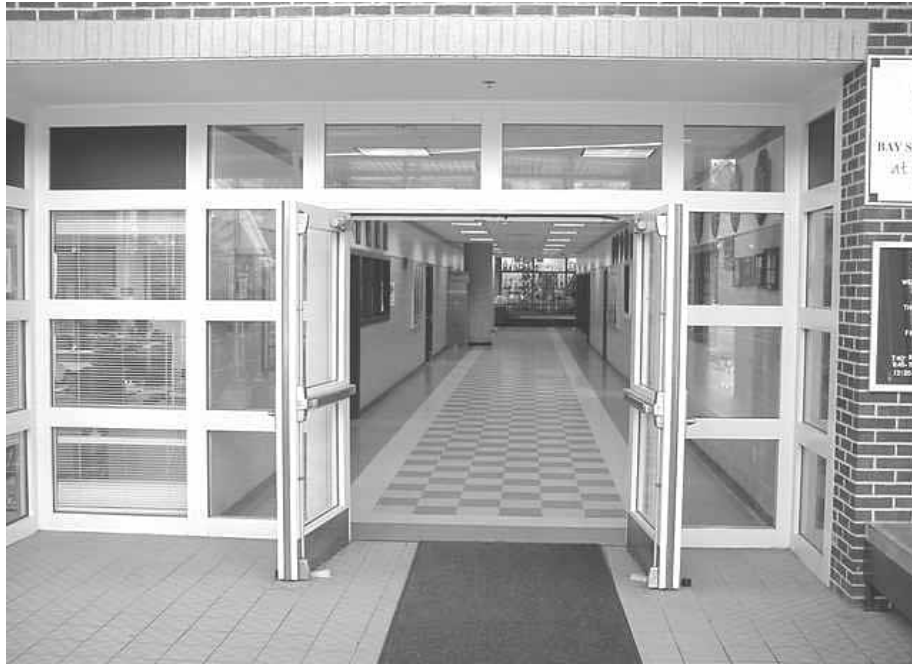
Picture 3

- As discussed, the administration and guidance/counseling offices are separated by a hallway (Picture 3). One end of the hallway opens to the building entrance foyer, the other into a hallway of the original building (Picture 4). The hallway leading to the old building is open, with no fire doors to partition the administration wing from the old building. The old building is not air-conditioned. The fresh air supply vents for the offices' hallway are connected to the offices' AHU. Therefore, chilled air is directed into the hall. The hallways, including the administration wing hallway, are not designed to be air-conditioned space.
- As discussed, air is drawn through plastic ceiling grates and returned to the AHU via the ceiling plenum, rather than by ductwork. BEHA staff found that the ceiling plenum in the offices' hallway was open to the ceiling plenum above non-conditioned sections

Offices' Hallway

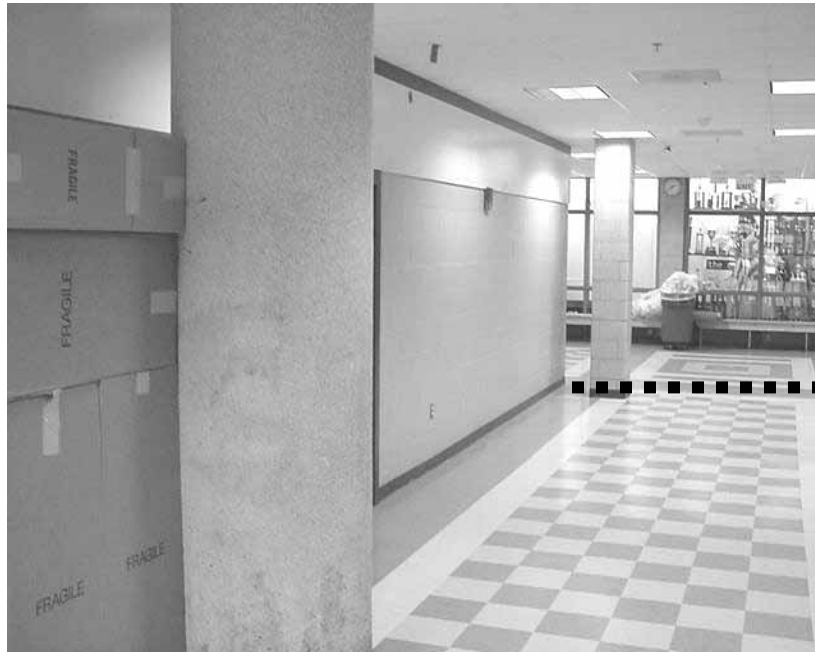
Picture 4

End of Offices' Hallway That Is Open to Old Building (Dotted Line Indicates Approximate Demarcation Between Air-Conditioned and Non-Air-Conditioned Space)

- b. Install fire doors at the open end of the offices' hallway to establish a *closed* air-conditioning zone. The door frame (or similar barrier) should be extended through the ceiling plenum and original ceiling to prevent the draw of unconditioned into the ceiling plenum. This option would establish a fixed volume of air for the ceiling plenum. With this option, it would be advisable to move the door from its original location to open into the air-conditioned hallway. The door relocation would then place the faculty lounge within the air-conditioned zone and prevent draw of unconditioned air from the hallway.

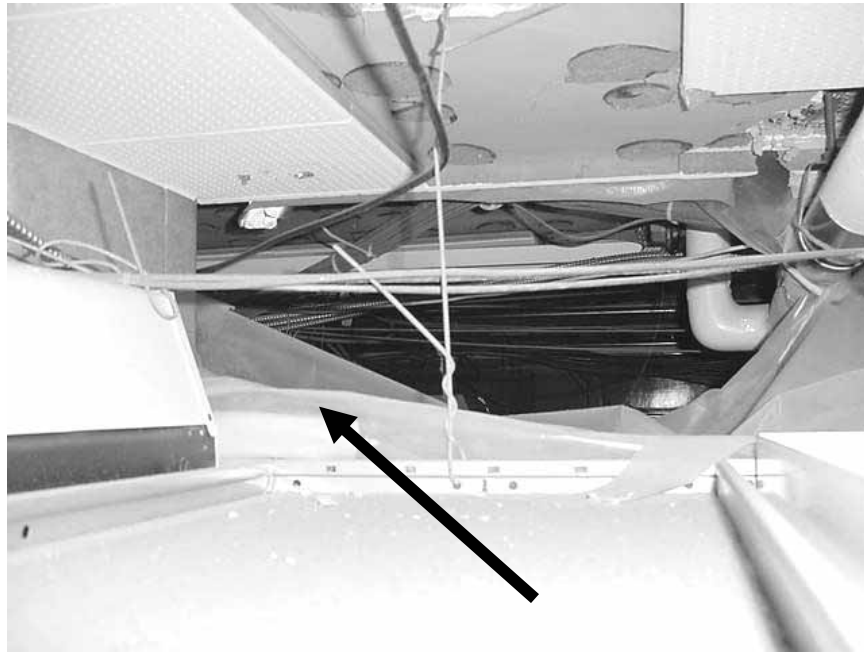
Picture 5

building. In this condition, the offices' AHU is drawing air from the ceiling plenum of the *entire* first floor. Since the ceiling plenum is an open space, unconditioned air from the ceiling plenum above classrooms and hallways is also returned to the AHU. It appears that a polyethylene plastic and duct tape "wall" was constructed to separate the offices' ceiling plenum from the plenum above unconditioned spaces (Picture 5). When this "wall" failed, unconditioned air was drawn into the offices' AHU.

**Plastic And Duct tape Above the Open End of the Office's Hallway at the
Approximate Demarcation between Air-Conditioned and Non-Air-Conditioned
Space**

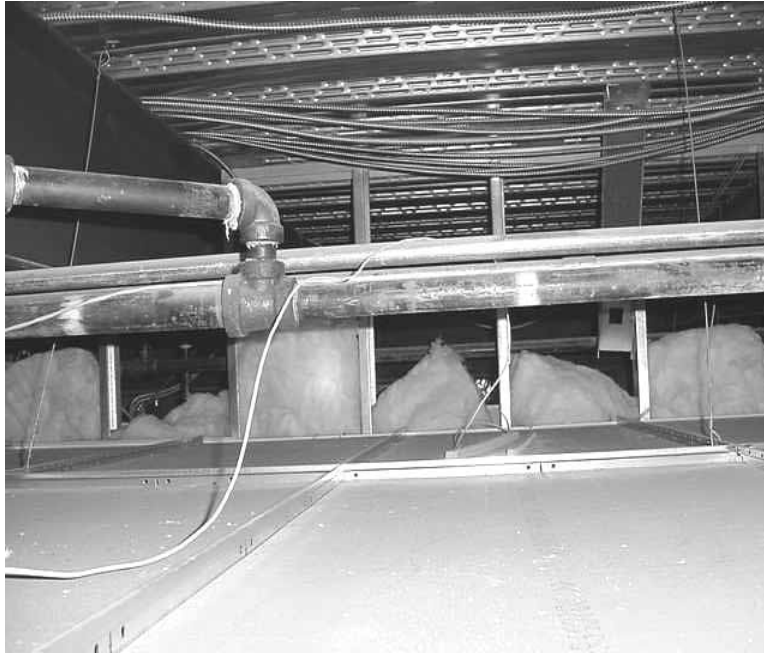
Picture 6

- Fibrous glass insulation bats were installed in the ceiling plenum between wall studs that hold the offices' hallway walls in place (Picture 6). The purpose of the fiberglass bats may have been to form a closed ceiling plenum for the administration and guidance suites that would be separate from the hallway ceiling plenum. These fiberglass bats were not affixed and had fallen from the metal studs, creating large openings for hallway air to be drawn into the offices' ceiling plenum.

Fallen Fibrous Glass Bats above the Office's Hallway Walls

- c. Install permanent insulated walls in the ceiling plenum above hallway walls where fiberglass insulation bats have fallen. Once in place, hallway fresh air diffusers should be disconnected from the offices' AHU. Diffusers should be replaced with ceiling tiles.

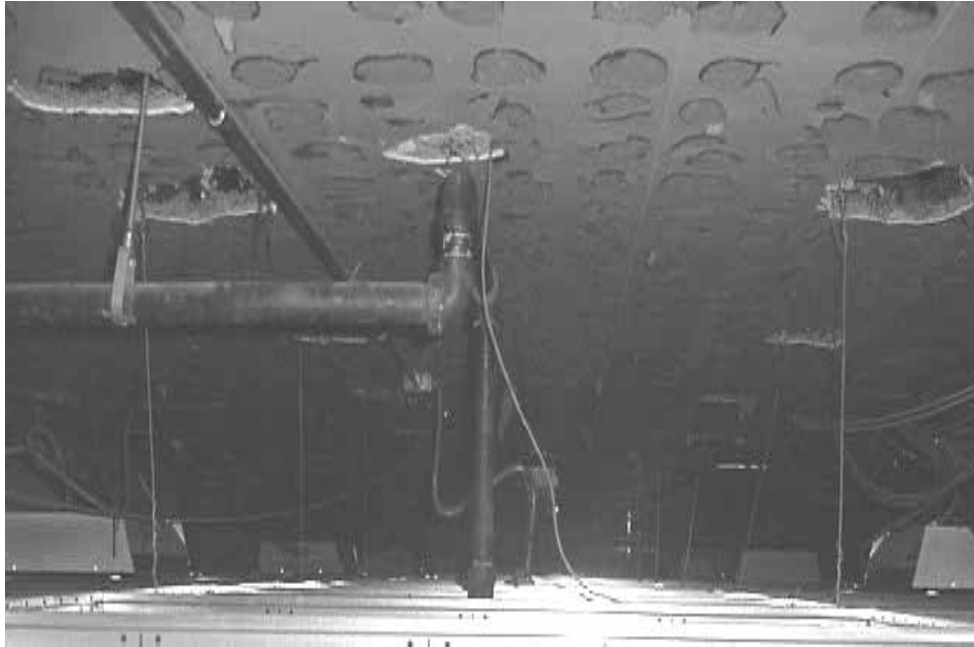
Picture 7

- The ceiling plenum was created by installing a suspended ceiling tile system below the original plaster ceiling in the hallways and classrooms of the original building. It appears that large holes were made in the plaster ceiling in order to install chains from which the suspended ceiling would hang (Picture 7). These holes create a breach through which unconditioned air above the original plaster ceiling can be drawn.

**Hole Punched Into Original Ceiling In Order To Hang Suspended Ceiling,
Sprinkler Pipes, Etc.**

2. Seal all holes made in the original ceiling to prevent draw of unconditioned air into the ceiling plenum of *first and second floor* rooms in the air-conditioned zone.

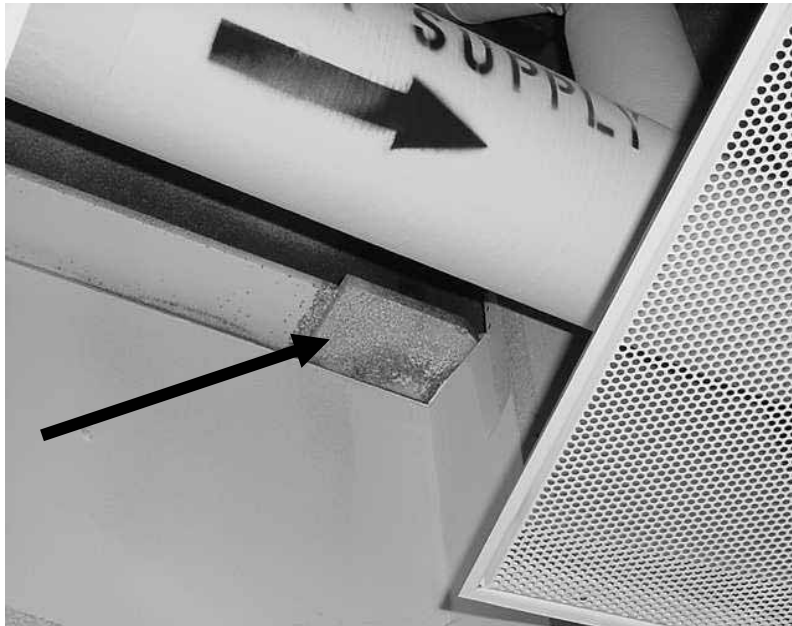
Picture 8

Rust Steel Beam above Mold Colonized GW in Guidance Suite Conference Room

1. Refrain from operating the chiller system of the AHU servicing first floor offices until the ceiling plenum is permanently closed.
2. Replace GW noted by GPS staff to have been wet or mold colonized.
3. Insulate the beam above the return vent in the guidance suite conference room to prevent condensation formation. The GW below this beam should be replaced.
4. Open windows in the guidance office to increase airflow when air-conditioning is not in use. When air-conditioning is operating, close windows.
